Article

Geomorphological Landscape Research and Flood Management in a Heavily Modified Tyrrhenian Catchment

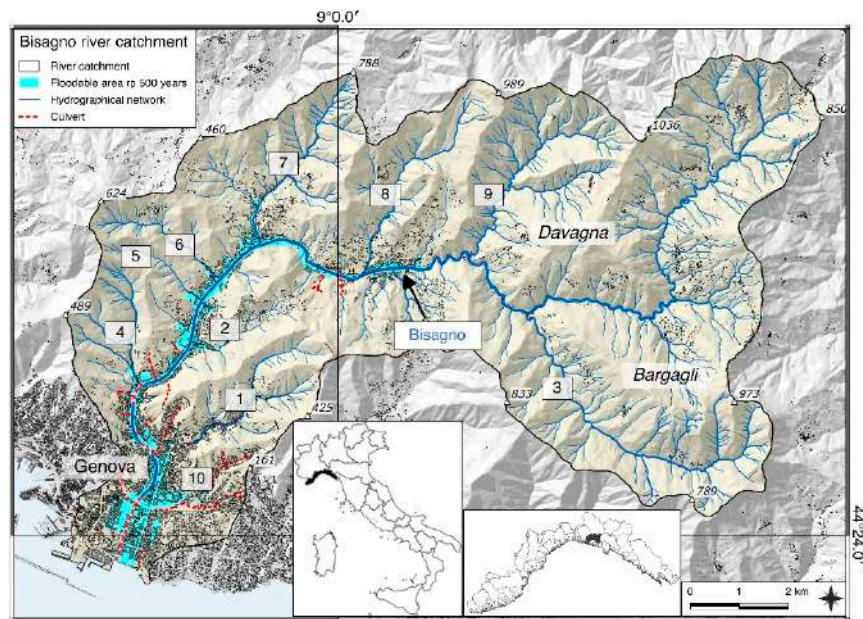
Figure 1. Geographic sketch map of Bisagno basin showing the floodplain, completely urbanised, and floodable areas of the valley floor; see Table 1 for details on subcatchments.

Between 1850 and the Second World War, the new urban areas mostly involved the bottom of the valley, which became almost entirely built up [34]. In the post-war period, new urban surfaces are found mainly on the hills of the lower stretch of the valley. The terminal stretch has been progressively incorporated in the city, while its upper part, NE of Genoa, which is included within the municipalities of Bargagli and Davagna still has some rural characteristics. Its drainage basin covers approximately 95 km² and the main stream has a total length of 25 km (Figure 1, Table 1).

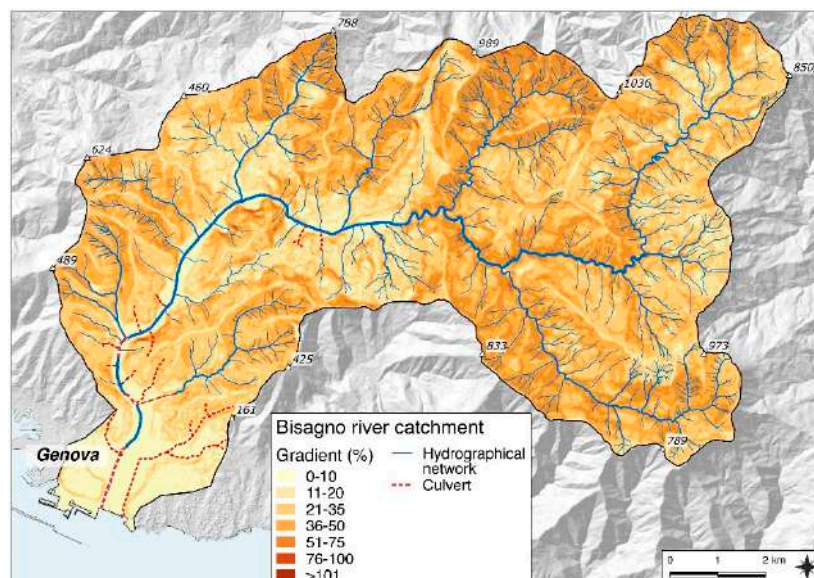
Figure 2. Slope map of Bisagno basin, from Digital Terrain Model (5-m resolution); the map shows the main elevations of the basin, concentrated in its northern and eastern part.

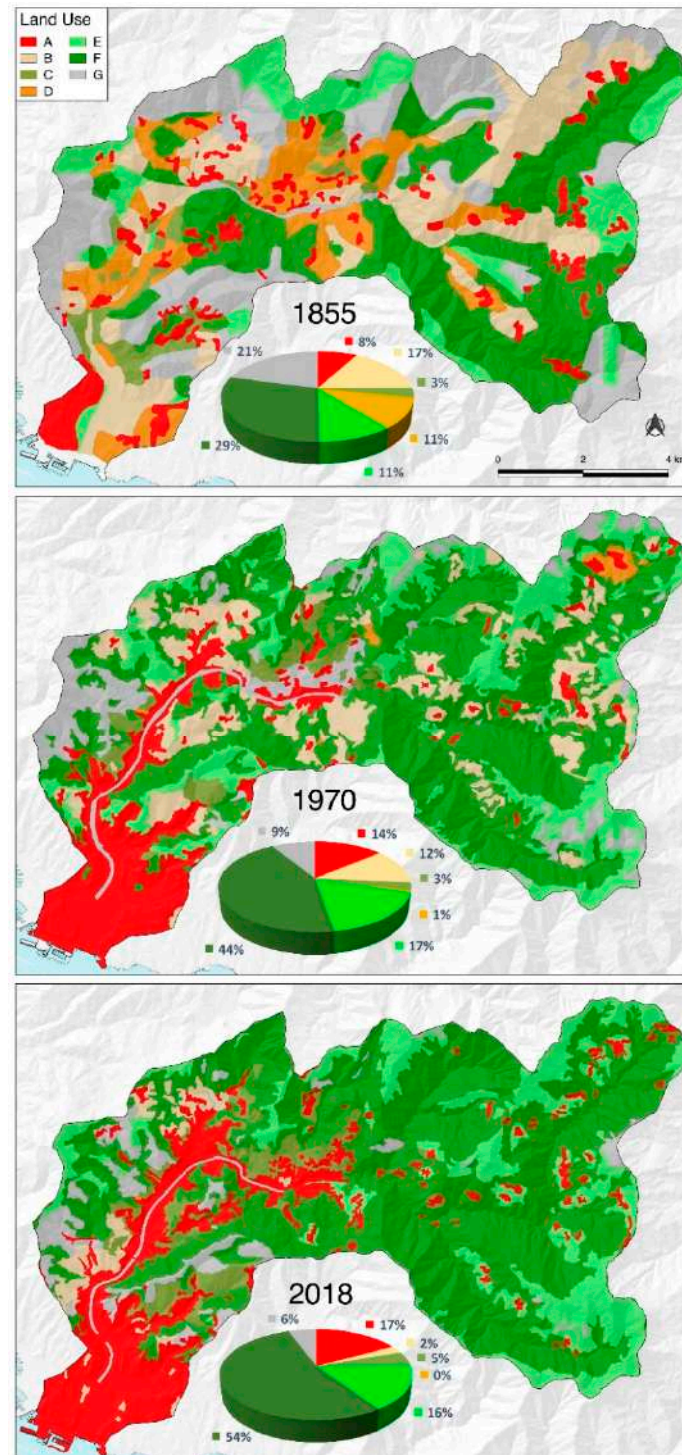
Figure 3. Land use sketch map of the Bisagno catchment in 1855, 1970 and present-day. A: urban, B: field, C: olive orchard, D: vineyard, E: pastureland, meadow, F: wood, and G: bare land, rock. The map underlines the high landscape diversity of the nineteenth century compared to 1970 and 2018. Today, two colours prevail, showing the significant extent of wooded surface and urban area.

The land use of the Bisagno catchment for 1850, 1970 and 2018 is shown in Figure 3. A remarkable decrease in agrarian surfaces is directly proportional to the increase in urban areas, which increased from 7.9 to 17% of the catchment. Fields and vineyards decreased dramatically, particularly the latter, which dropped down to 0. In some areas, vineyards were replaced by olive plantations, which is the only stable land use class. In 1850, cultivated fields were spread across the whole basin, while in 1970, they were concentrated along the bottom of the valley and at lower elevations. The higher slopes, which in the nineteenth century were mainly open and used as pastureland and for haymaking, went through progressive secondary reforestation and, today, woodland is the most prominent land use category, covering over half of the entire basin.

terraces around the villages; (b) how, today, managed or cultivated terraces only represent 26% of the total terraced area. in accordance with the results of Figure 3, which shows the progressive loss of cultivated fields and vineyards in the rural parts of the valley, the reduction of managed terraces is more significant in the upper catchment, distant from the main settlements.

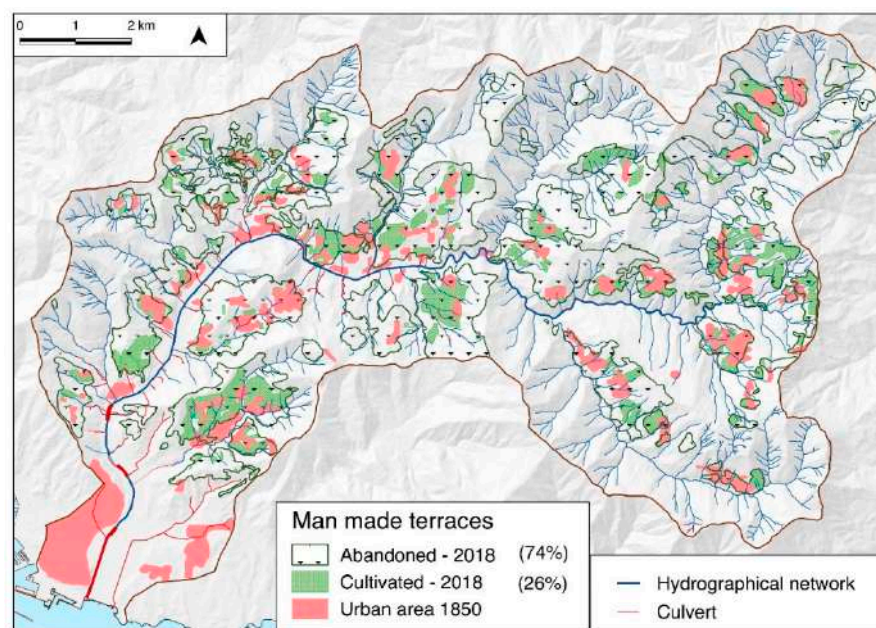
Figure 4. Terraces with dry stone walls map. Abandoned terraces are mainly located far from the urban area.

The map of Figure 4 shows the total surface of terraced areas in the Bisagno catchment (30%) in relation to the Genoa urban area and rural settlements in 1850, highlighting: (a) the distribution of

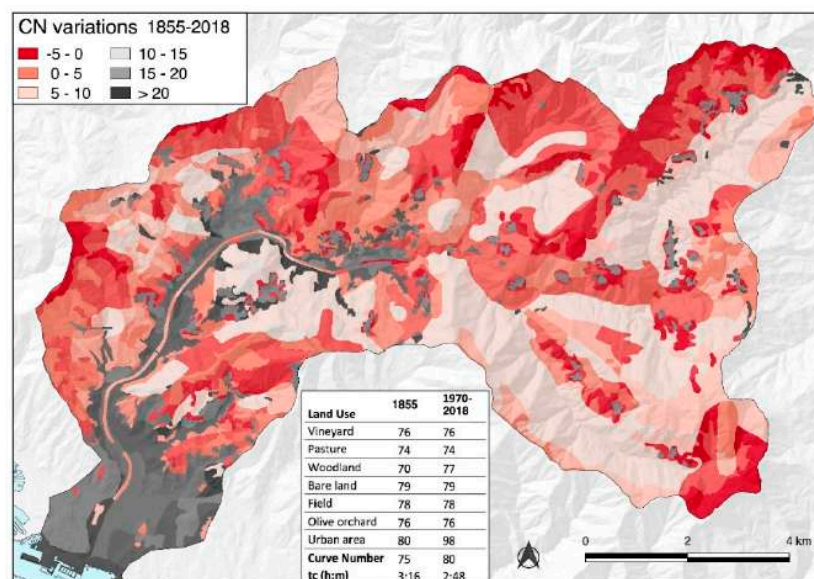
Figure 5. Curve Number variations between 1850 and 2015; the table shows its recent increase which is due to land use changes, particularly the increase in woodland and urban area and the reduction of managed agricultural land.

For the analysis of the Curve Number, we applied the parameters from the SCS-CN tables [61,64] assigning different values to two categories, woodland and urban surface, depending on the year. If compared to 1850, the urban surface, today, is more compact and continuous, particularly because of the presence of a dense network of new asphalt roads (CN = 80–98), while woodlands, today, are in poorer condition due to lack of management (CN = 70–77). The CN passes from 75 in the nineteenth century to 80 in 1970 when most of the landscape variations had occurred. The analyses show an increase in the CN in the last 200 years due to land use changes: the significant CN increase due to urbanisation of the floodplain is only partly balanced by the increase in woodland in the upper catchment (Figure 5). The concentration time passes from 3h 16' to 2h 48'—a very significant variation in a small basin with very rapid hydrological responses.

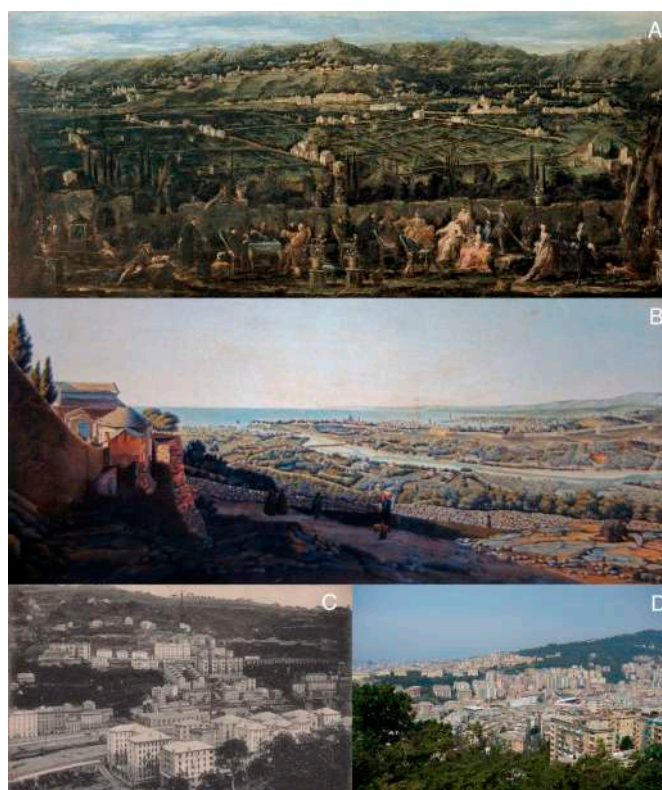
Figure 6. Historical images and landscape changes in the lower stretch of the Bisagno Valley: (A) Alessandro Magnasco, 1740 (collezione Palazzo Bianco, Genova, from <https://bit.ly/33Qw4fZ>); (B) Luigi Garibbo, c. 1825 (Centro DocSAI, Genova, Coll. Topografica); (C) historical photograph, 1929 (from <http://ceraunavoltagenova.blogspot.com/>); (D) present-day. The views, taken from the eastern side of the valley, document the landscape of the pre-industrial period, when the Bisagno area was devoted to agricultural production for the city of Genoa. The urbanization process started in the early twentieth century, initially along the valley and successively on the hills. Today, urbanization is complete.

The comparison between paintings and photographs of different historical periods provides evidence of the remarkable landscape changes in the lower Bisagno valley in the last three centuries (Figure 6). Painting (A) is a view by the Genoese artist Alessandro Magnasco (1667–1749) which depicts the “villa landscape” typical of the Genoese countryside in the pre-industrial period. The painting highlights the regular pattern of walled fields in the valley bottom, which was intensively exploited for agriculture and characterised by scattered houses. The hills around, partly terraced, are completely open and scarcely urbanised, the main settlements being along the ridges. The situation is very similar in 1825—the date of a watercolour by Luigi Garibbo (1784–1869) (Figure 6B). The view is taken from Madonna del Monte, on a prominent hill along the left watershed of the valley which became a very popular viewpoint among artists in the nineteenth century [65]. Garibbo depicts with detail the diverse and well managed rural landscape of the valley in the early nineteenth century, characterised by small cultivated fields, olive orchards and vineyards on terraces, with the city of Genoa, surrounded by the city walls in the background. By 1920, the situation is completely different: these are the years of Genoa’s industrial and urban development, and as the photograph of Figure 6C shows, the bottom of the valley is almost completely built up, while the hill above is only partly urbanised. By this period, the lower Bisagno valley had already almost entirely lost its traditional agriculture, but the process soon involved the hills around the city, which by 1970 also became heavily urbanised. Today, both the valley and the hills immediately above are intensively built up, with only the highest part, next to the old Genoa walls, still open. Hardly any sign of rural exploitation and management is detectable in the landscape.

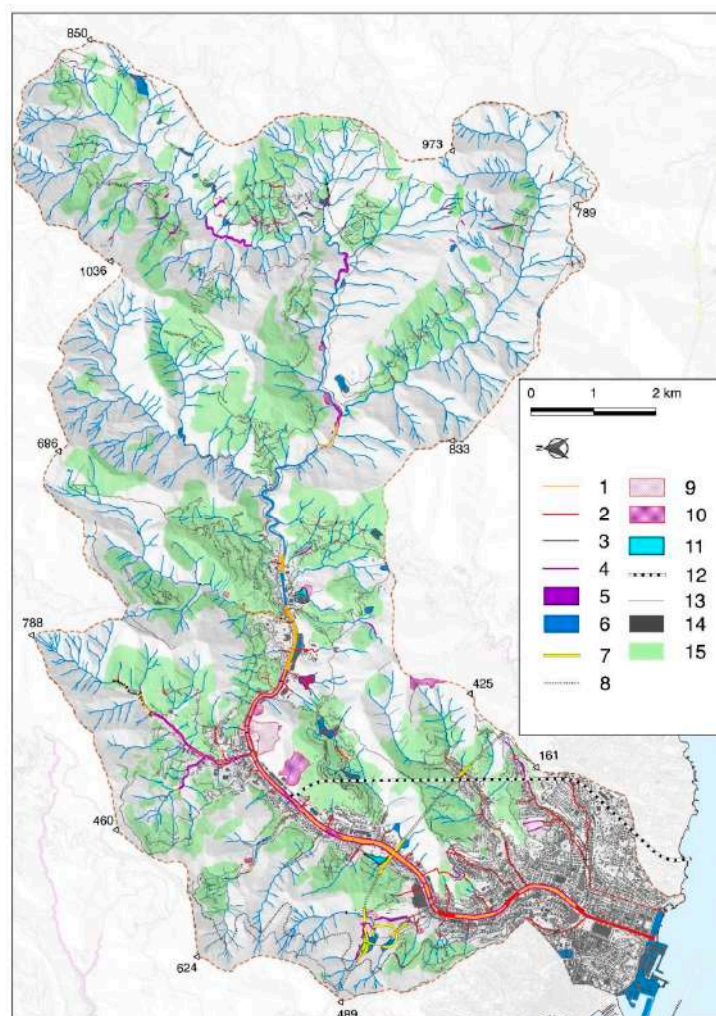
Figure 7. Anthropogenic landforms in the Bisagno stream catchment: MODIFIED RIVER NETWORKS: 1. Artificial rivernetwork; 2. Culvert; 3. Weir; 4. Riverbank. MADE GROUNDS: 5. Dump; 6. Landfill, embankment; 7. Motorway; 8. Railway; WORKED GROUNDS: 9. Active quarry; 10. Inactive quarry; 11. Excavation surface; 12. Drainage channel (final design). INFILLED GROUNDS: 13. Road. LANDSCAPED GROUNDS: 14. Buildings; 15. Terraces (with dry stone walls).

Figure 7 shows the main anthropogenic landforms of the Bisagno stream catchment, an area internationally known for its artificial grounds that have been a dominating morphogenetic process since the C19th. Rosenbaum et al. [66] classifies them into made ground, worked ground, infilled ground and landscaped ground. an additional category is represented by main and secondary hydrographical network. Amongst made grounds, we can summarise dumps, landfills, sea embankments, railway and motorway. Worked grounds are open quarries for the extraction of marly limestone, whose unmanaged fronts often undermined slope stability. Amongst infilled grounds, there are mid-slope roads, with cuttings and fills and some quarries, partly refilled today. Terraces are a particular example of landscaped ground; their building, which probably dates back to the Middle Ages [16], means significant modifications of the slopes of the most superficial stratigraphy of the soil. Built up areas are landscaped grounds too, both along the valley and on the slopes; their buildings entailed a large movement of material, although in this case the distinction between areas of excavated and areas of made ground is difficult to discern. The main hydrographical network has been intensively modified, with culverts, canalisations and narrowing of the river bed, while minor streams are characterised by river bridges built to reduce erosion and improve embankment stability. The valley is crossed by a railway track and by a motorway, while a mid-slope narrow-gauge railway goes along the right-hand side of the valley.

Anthropogenic landforms characterize the final stretch of the valley floor, but important modifications also involved the valley slopes, as shown by Figure 7. Moreover, a very dense network of paved roads has replaced the old mule tracks, increased soil sealing and cut through the slopes, contributing to soil instability and modifying the hydrographical network.

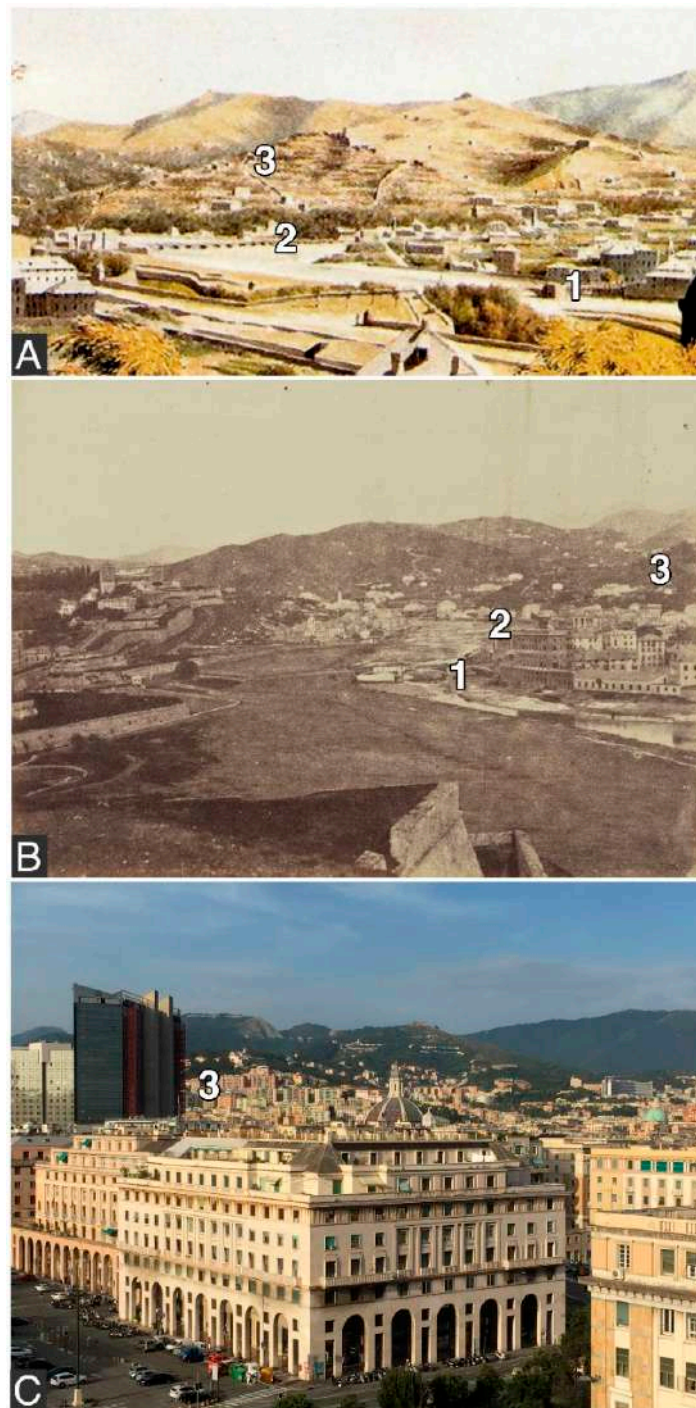
Figure 8. Photographical comparison of the final stretch of the Bisagno floodplain from the western side of the valley at Carignano: (A) L. Garibbo, 1822 (Centro DocSAI, Genova, Coll. Topografica); (B) Jane St John, *Genoa from the Ramparts*, 1856–1859; The J.Paul Getty Museum, Los Angeles, Digital image courtesy of the Getty’s Open Content Program; (C) present-day. The numbers show three specific sites of the valley. 1: Pila bridge; 2: Sant’Agata bridge; 3: Monte hill.

The Bisagno riverbed channel has been severely constricted in the last 200 years. Figure 8 focuses on the terminal stretch of the valley, providing evidence of the progressive narrowing of the riverbed alongside urbanisation. The process of urbanization of the Bisagno floodplain started in the first decades of the twentieth century and, today, the area is almost completely built-up. The first drawing, by the Genoese artist Luigi Garibbo shows the situation in the early nineteenth century, with the wide and empty river bed of the Bisagno crossed by the St. Agata and Pila bridges; before the narrowing of the river channel, they were respectively 280 and 120 m wide. The floodplain had several water channels used for irrigation and water regulation. Until 1823, the village of Borgo Pila, next to the river mouth, was five metres higher than today; it was lowered at the end of the nineteenth century to facilitate the road link with a new road to the centre of Genoa (now Via XX Settembre) over Pila Bridge. In addition, a small hill between Borgo Pila and the city centre, which was part of the river's western edge, was dismantled in the same period. The situation is similar in the mid-nineteenth century, when the British photographer Jane St John (1801–1882) took a photograph of the area from the old city walls (*FrontiBasse*); the riverbed is wide and open, and the landscape has only scattered buildings and settlements. Today, urbanisation is complete—the embankments are characterised by roads, warehouses and factories while the alluvial plain and the sides of the valley are heavily built up with residential buildings and more culverts were established. The bridge of St. Agata is no longer visible from the same viewpoint; it is 70 m wide and only 5 arches remain of the original 28, while the Pila Bridge no longer exists.

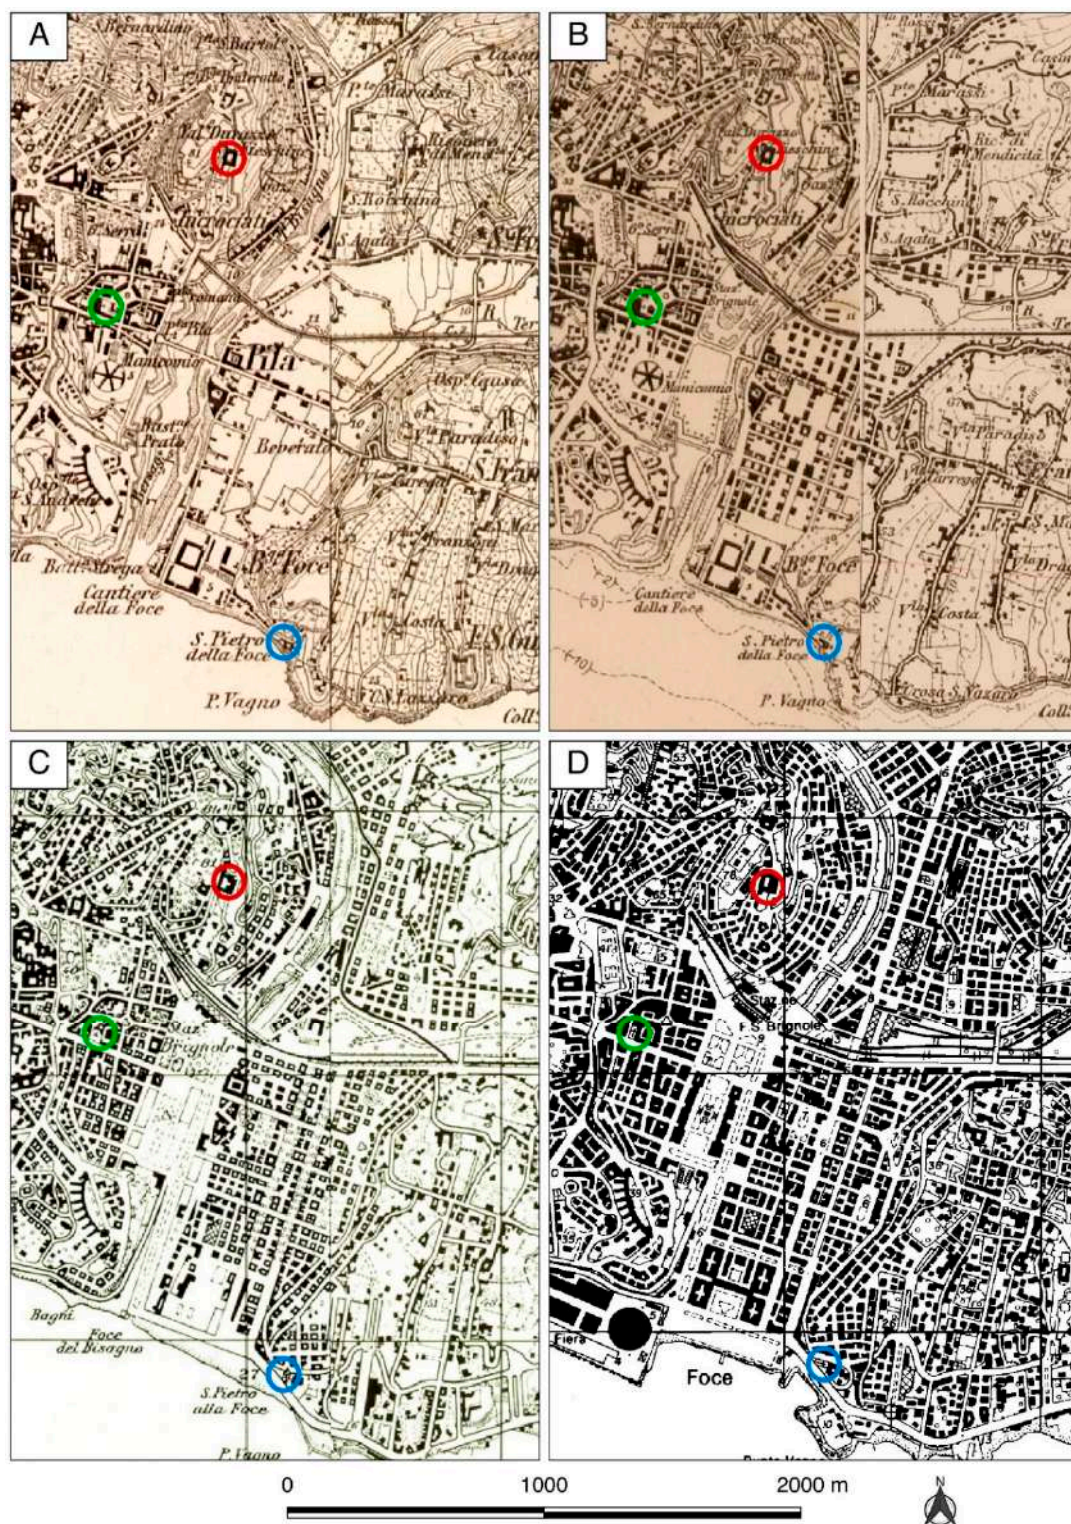
Figure 9. Multitemporal comparison of historical maps of the terminal stretch of the Bisagno Valley: (A) Tavoletta Istituto Geografico Militare Italiano (IGMI), 1878; (B) Tavoletta IGMI, 1907; (C) Tavoletta IGMI, 1939; (D) Regione Liguria, 1997. **Blue circle:** San Pietro church; **Green circle:** Consolazione church; **Red circle:** Fieschine convent.

Figure 9 documents the gradual occupation of the fluvial plain as shown in historical maps from four different periods between 1878 and 1997. The buildings have increased from 65,000 to 305,000 from the second half of the nineteenth century to today [67] and the river width decreased dramatically, passing from c. 250 metres (1878) to 50 metres (today) at St. Agata. By 1930, new buildings, roads and railways had been established including the new Genoa–Tuscany railway line and Brignole railway station, and the river was already partly channelled. The maps show the urbanisation of the plain and the construction of the final culvert on the Bisagno in c.1930. However, the flow section was based on incorrect calculations which underestimated the maximum flow rate of the Bisagno, based on the assumption that the maximum flow rate could not exceed 500 m³/s [45]. This value is significantly smaller than the water flow peaks that, in recent years, the stream has reached during its most violent floods. In the same period the Fereggiano Stream (the last left tributary of the Bisagno), was embanked first and then covered for over 1 km. Other parts of this stream were culverted in the 1950s and at the beginning of the twenty-first century. Today, almost 40,000 people live in the terminal stretch of the Bisagno Valley (Foce district), characterised by a very high flood hazard [33].

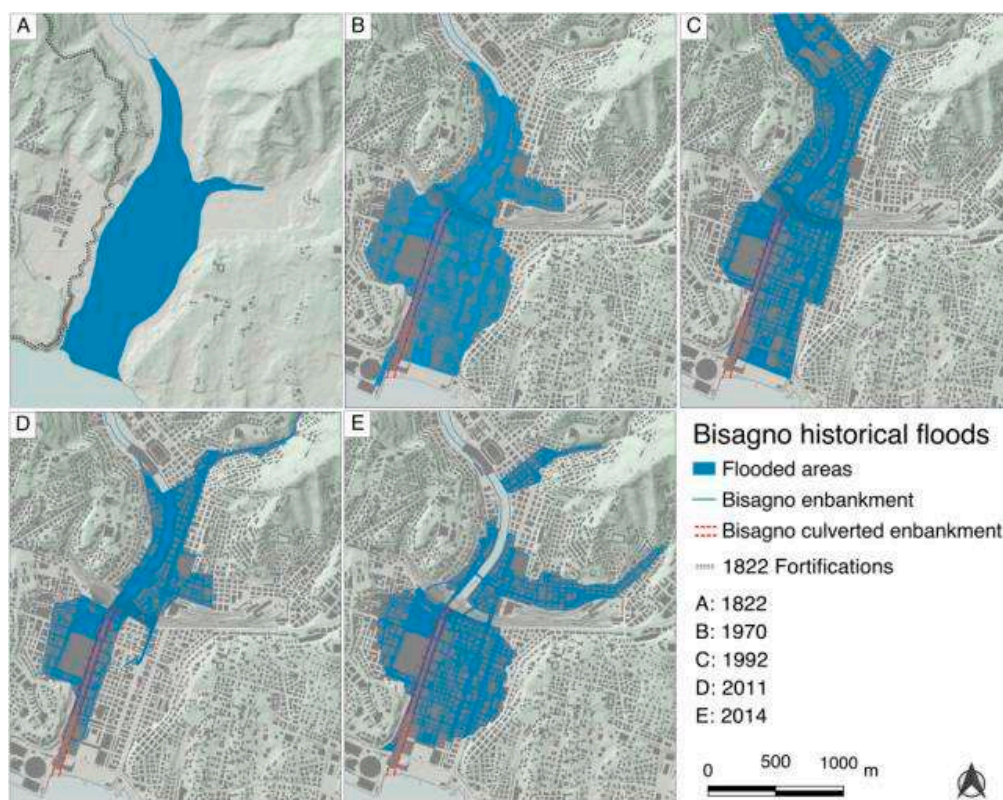
Figure 10. Historical flooded areas of the Bisagno floodplain during the most significant flood events of the last two centuries. Since 1970, the Bisagno floods have affected a densely urbanised area.

century. The maps of Figure 10 show the flooded area of the five most significant flood events of the period. The terminal floodplain is flooded in every flood event, although with different distribution and water heights depending on the flood entity and the morphological and urbanisation conditions.

The 4 November 2011 event was a flash flood which struck the Fereggiano Valley with a peak of rainfall of over 500 mm/6 h [32]. The stream rapidly overflowed at approximately 1 pm, flooding the roads and washing away cars, buses and people; maximum water height was 1.5 m. There were six fatalities and 150 million euros of damage. The rainfall and discharge peaks were concentrated in the Fereggiano, the tributary of the Bisagno, and the flooded surface shown in Figure 10 is different from the others.

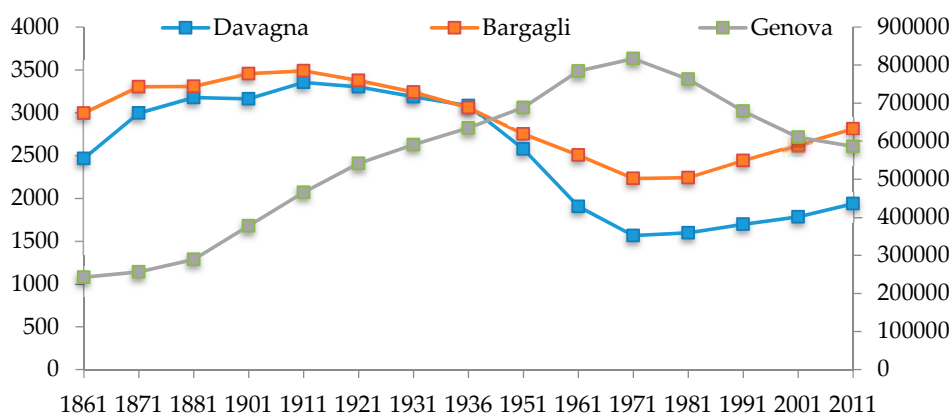
Figure 11. Demographic changes in the Bisagno Valley Municipalities in the last 150 years (data from Italian Institute of Statistics).
